ENGINEERING CASE STUDY MYSTERY CURRENT

**By Patrick J. Lynch P.Eng.
POWER LINE SYSTEMS ENGINEERING INC.**

Where is all that current coming from?

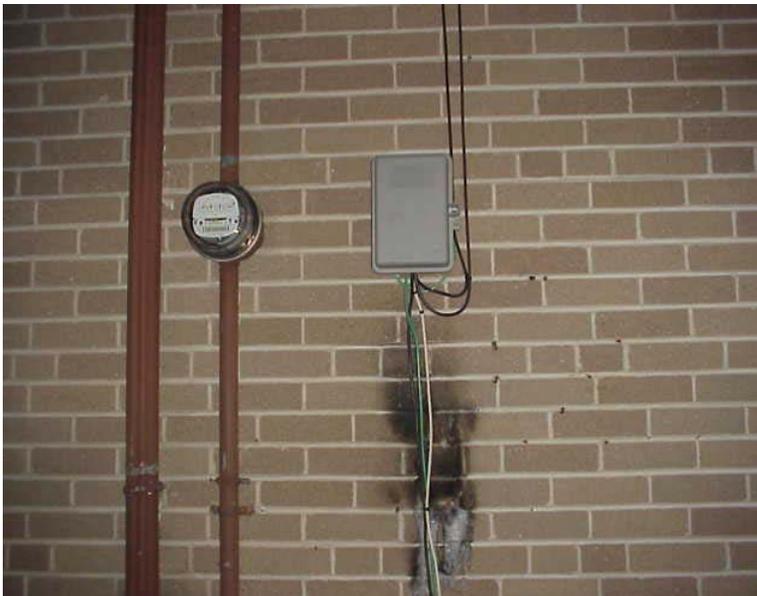
FIGURE 1

We initially got the call from a very frustrated cable TV engineer. Apparently, the plastic cable TV splitter boxes were melting off the wall at many homes, however, only in one specific area of town. The outside house cable TV grounds would also generate a "spark" each time an attempt was made to connect it to the outside house electrical utility ground. (Refer to movie link attachment in email.) and/or http://powerlinesystems.ca/users/plynch/arcing_currents_10sec.mpg

New plastic cable splitter box installed on the homeowner's wall above the remnants of the other plastic melted cable splitter box.

Actual measurements between these 2 grounds (cable & utility) at this site revealed a 35 Volt difference and over 20 Amps of current flow between these 2 grounding systems.

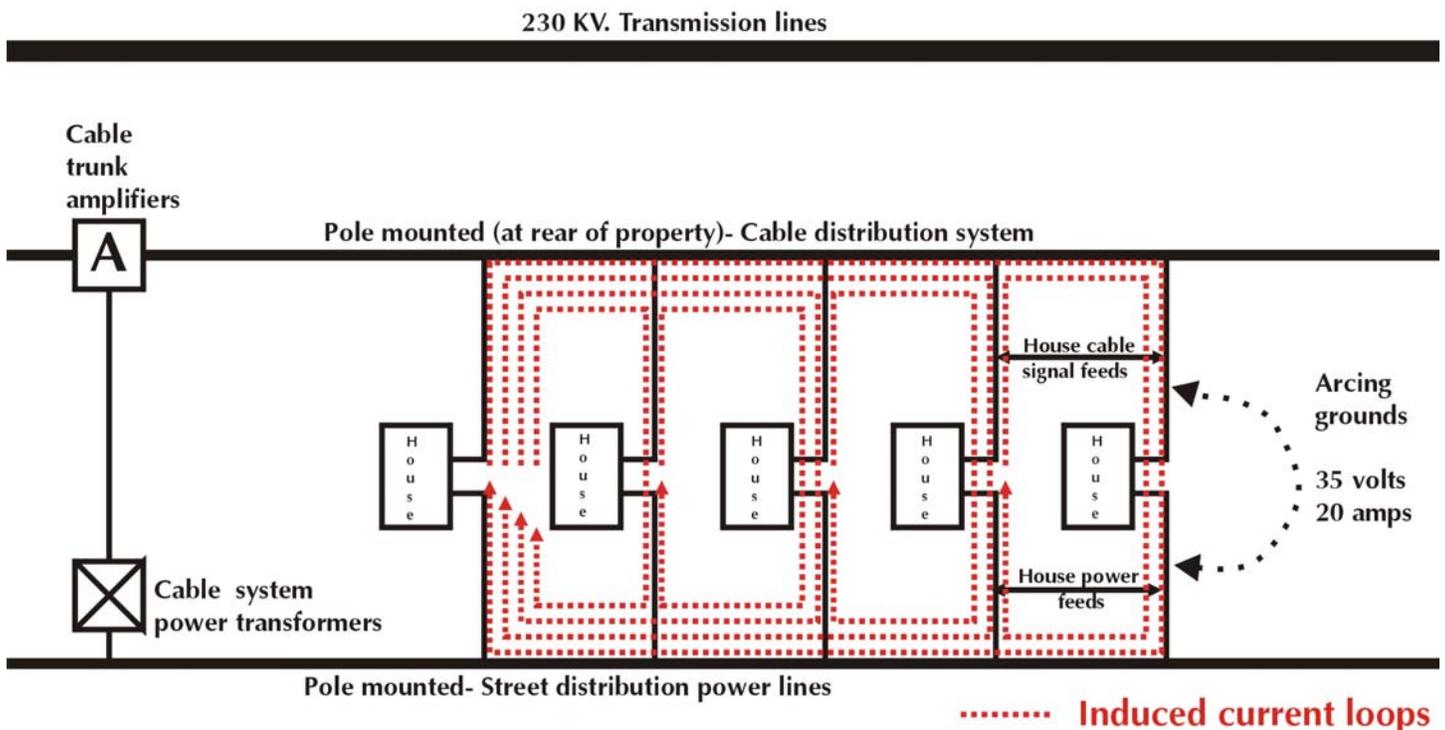
ELECTRICAL LAYOUT ARRANGEMENT -TOP VIEW

Directly behind these houses, was a 230 KV. high voltage transmission line corridor. It would appear the 60 Hz. magnetic field generated by the current flow through these transmission lines was magnetically inducing current to flow into this 5' foot diameter loop of wire.

A much larger magnetic induction loop had been inadvertently created between the electrical distribution utility power ground system and this cable TV installation. This larger loop area, perpendicular to the 230 KV. transmission line magnetic fields, then allowed a correspondingly higher 20 Amps of circulating current to flow.

To reduce this induced current loop area, would require the complete relocation of this cable system for this community. This would involve the teardown and rebuild of this entire cable system. We arranged for the distribution utility to immediately grant access for this new cable system to be installed on their street utility poles. Note: Normally this utility pole access permit approval process could take up to 2 months. All the on-site truck crews were then immediately transferred to the cable infrastructure rebuild process.

After the rebuild was complete, the circulating current between the grounds in these 2 systems has now been reduced to less than .5 Amps for this entire community.
